# Glass Fibre Roof Condition Report Follow-Up

## Meeting and Progress Assessment

**Date and time:** 0940 hrs Monday 19th August 2020 at [REDACTED]

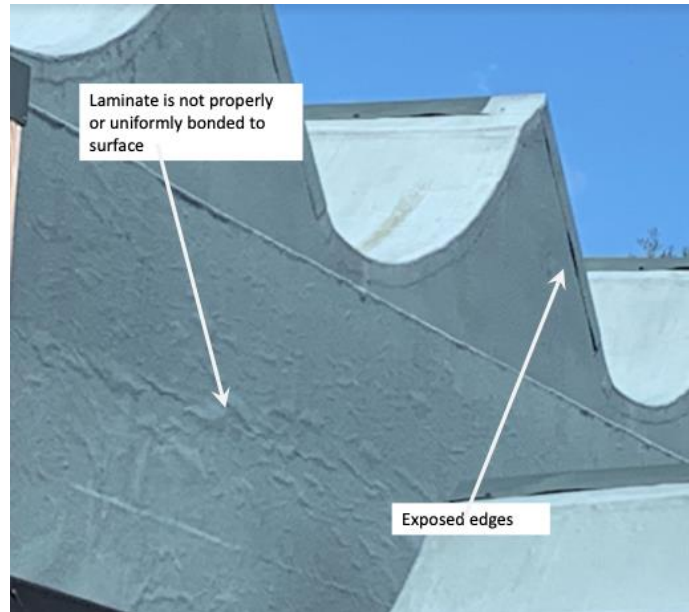
The image below demonstrates the sub-standard laminating detail to elevations in the public eye. The vertical clad area displays unsightly rippled and blown laminate that does not compliment the structure.

**Figure 3. Poor quality laminate showing signs of poor adhesion and air underneath the surface. This could be due to the absence of a paddle roller during application.**
