# Glass Fibre Roof Condition Report Follow-Up

## Meeting and Progress Assessment

**Date and time:** 0940 hrs Monday 19th August 2020 at [REDACTED]

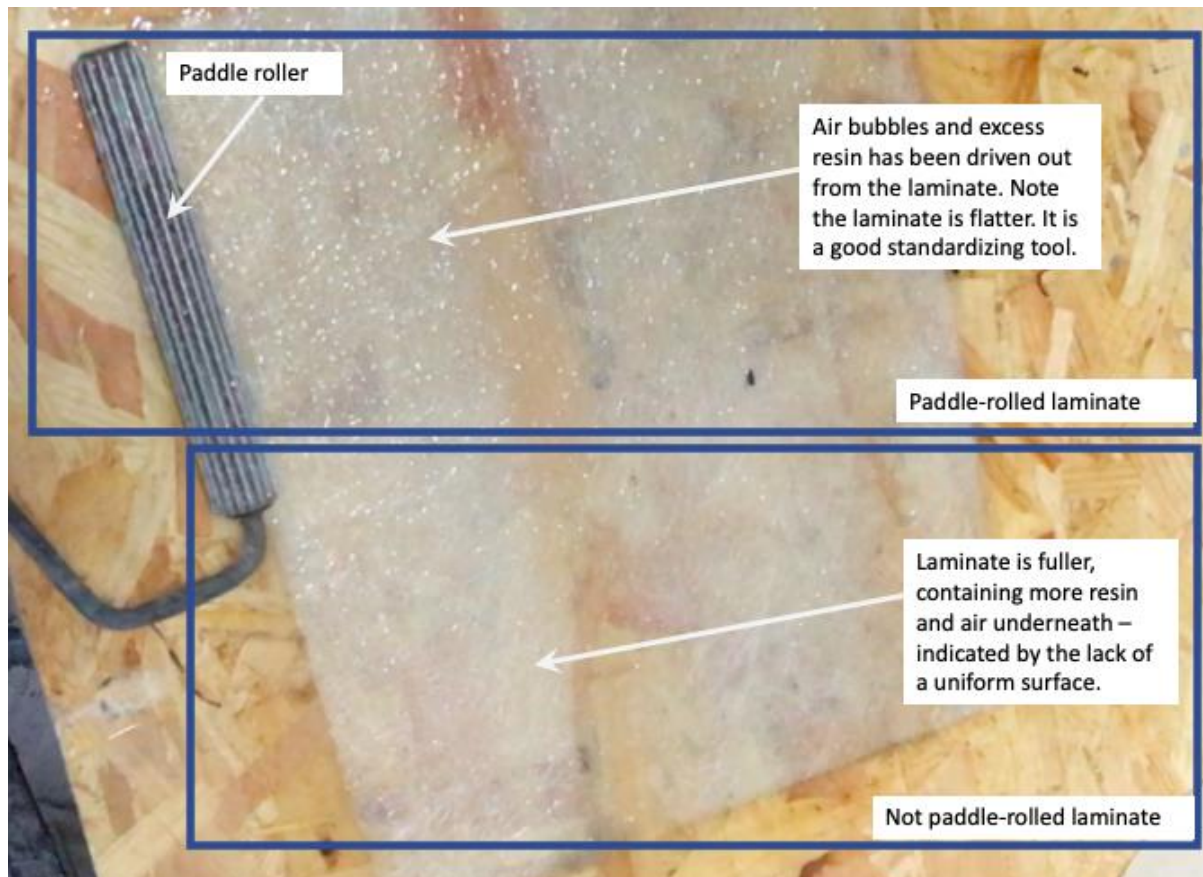
There is a noticeable absence of the use of a paddle roller (used extensively in the GRP laminating industry) to consolidate the resin and matting. Moreover, its purpose is to drive out air bubbles trapped in the resin. Bubbles create structural defects in the laminate and open it to cracks and water ingress.

**Figure 2. Comparison of with / without paddle roll usage during laminating**

Evidence of the lack of use of this tool is general throughout the installation and subsequent repairs. This was illustrated by glass fibres protruding from the laminate and the lack of a homogenous surface. The resultant appearance is as if the resin has been applied by a soft roller only as a time-saving procedure.

The resin is driven through the immediate work area assisting in eradicating any possible 'dry' areas and ultimately providing a stronger and finer finished laminate.
